# **SULLIVAN COUNTY UNITY COMPLEX BUILDING ASSESSMENT**

## **PHASE ONE ARCHITECTURAL AND STRUCTURAL EVALUATION**

**SULLIVAN COUNTY NH – BOARD OF COMMISSIONERS**

**26 August 2005**

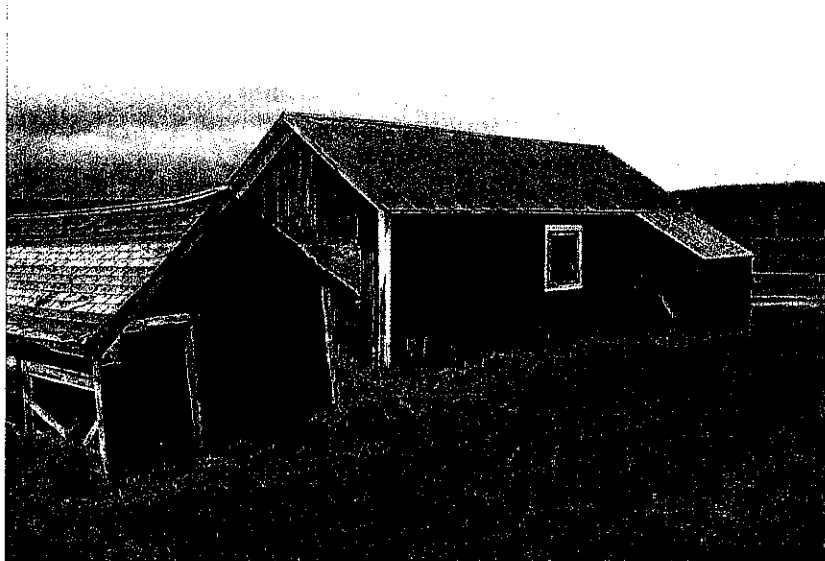
The building numbers for this study will model the review from Bob Hemenway dated 1998 for ease of comparison. *See site plan.* MacConnell Special Care Unit (Building Number 1), Stearns Building (Building Number 2) and Ahern Building (Building Number 14) are not included in the scope of this report. The Chicken Coop (Building Number 10) and Shed (Building Number 11) are wood structures with vertical siding and metal roofs to the south east of Tractor Barn (Building Number 9). Both the Chicken Coop and Shed are in very poor condition and should be demolished. *See photo A1.*

**Photograph A1** – 04/28/05 Chicken coop and shed.

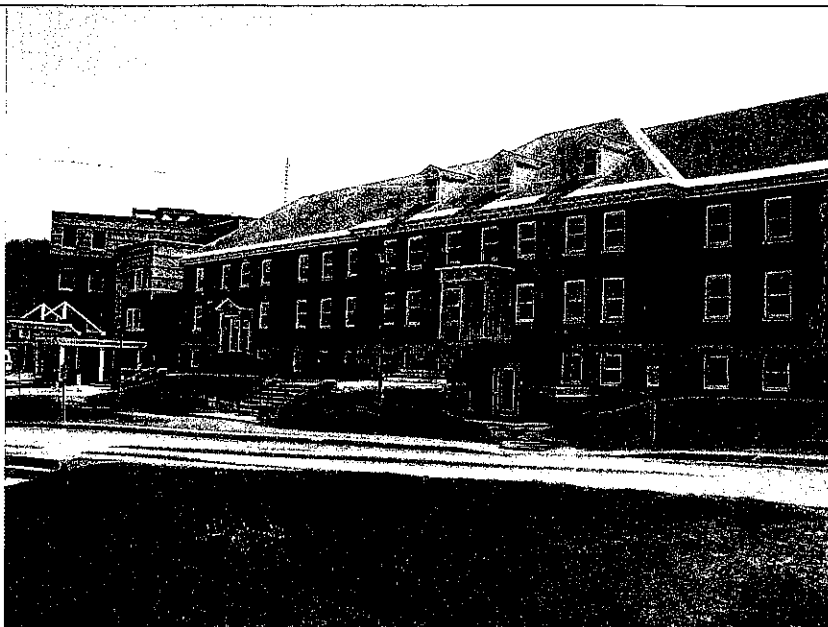
**Photograph A2** - 04/28/05 – Sanders Building (Building #3): North elevation of Sanders showing main entry and access to ground level.

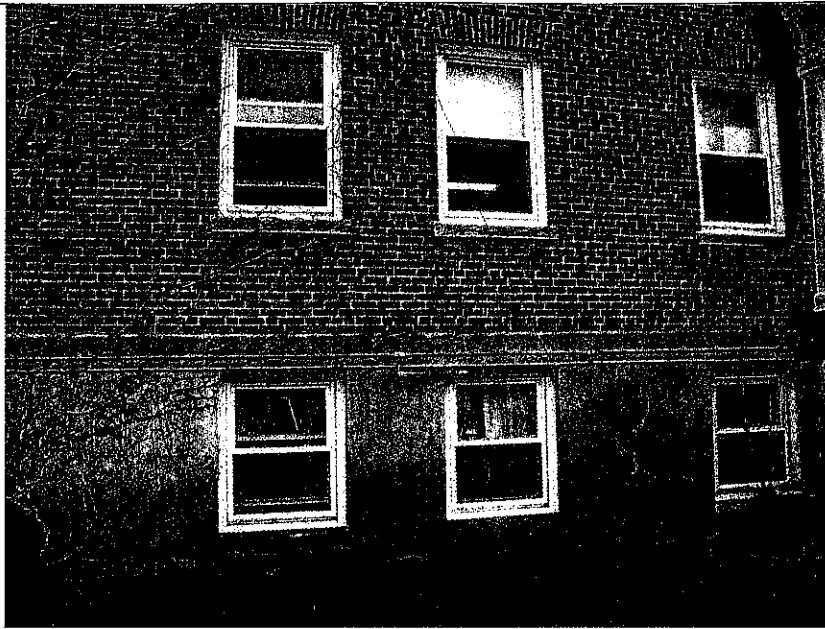
The brick appears to be in good condition. Vines that are present on the façade may cause damage to the masonry over time; it is advisable to remove all vines from the building. The concrete has a stucco finish that appears to be damaged at several locations. Some staining from water at the ground is present. A gutter and leader system, which will allow for water to be deposited beyond the extents of the building,

**Photograph A5** – 04/28/05 – Sanders Building (Building #3): Vines on the concrete and masonry. All vines should be removed from the façade.

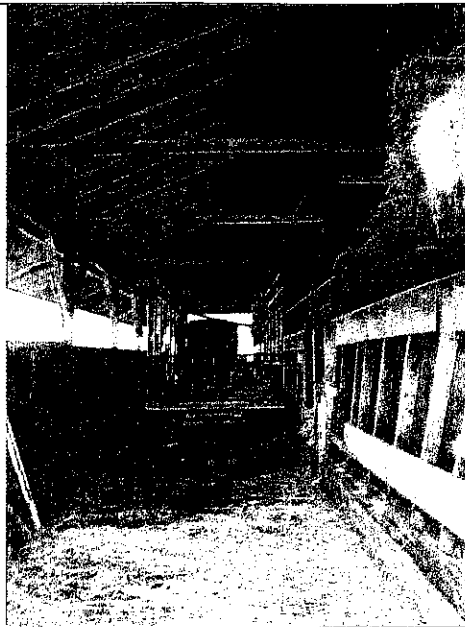
The Heifer Barn is a single story structure consisting of three bays with a hayloft above the central bay. The wood framed barn has heavy timber posts, concrete raised foundations and a corrugated metal roof. The bay to the south is an open perimeter bay that currently has vehicle stored within. The two inner bays are set for livestock with metal railings dividing the stalls. The barn is presently used for storage. *See photo A18, A19, and A20.*

**Photograph 19** – 04/27/05 – Heifer Barn (Building #6): Open bay structure.

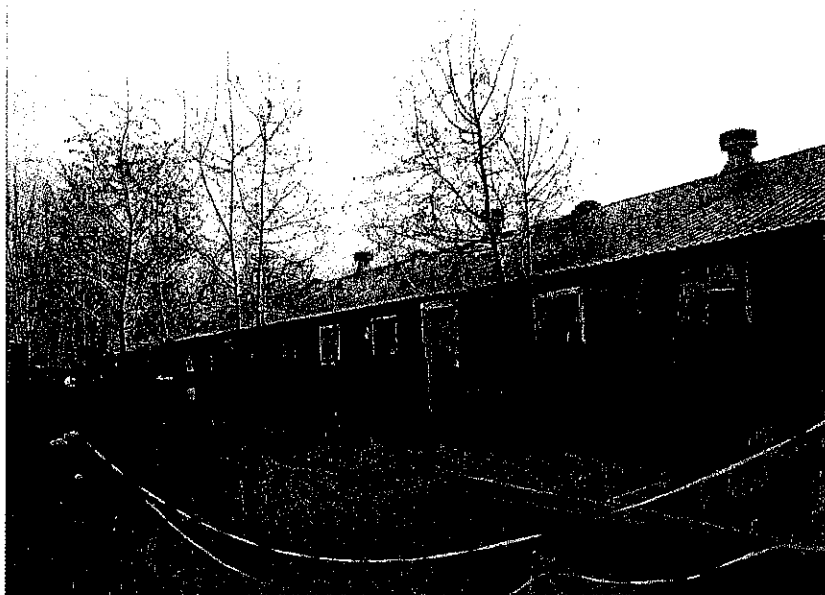
**Photograph 25** – 04/27/05 – Pig Barn (Building #7): Trees should be removed in the area between barns

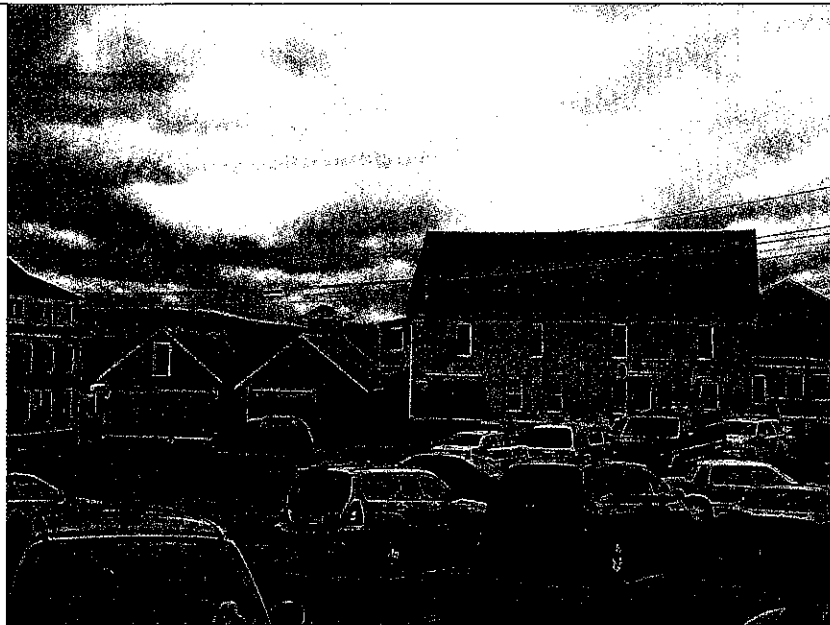
**Photograph 50** - 04/27/05 – Two Car Garage (Building #17 and #18 ) with Apartment Building.

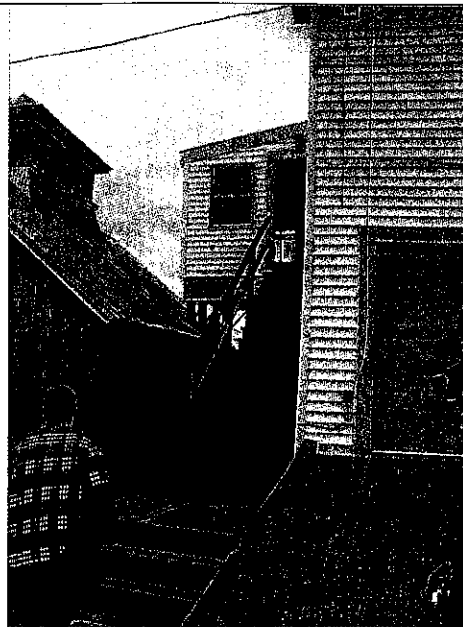
**Photograph 51** – 04/27/05 – Two Car Garage (Building #18): Adjacent porch bearing on garage roof

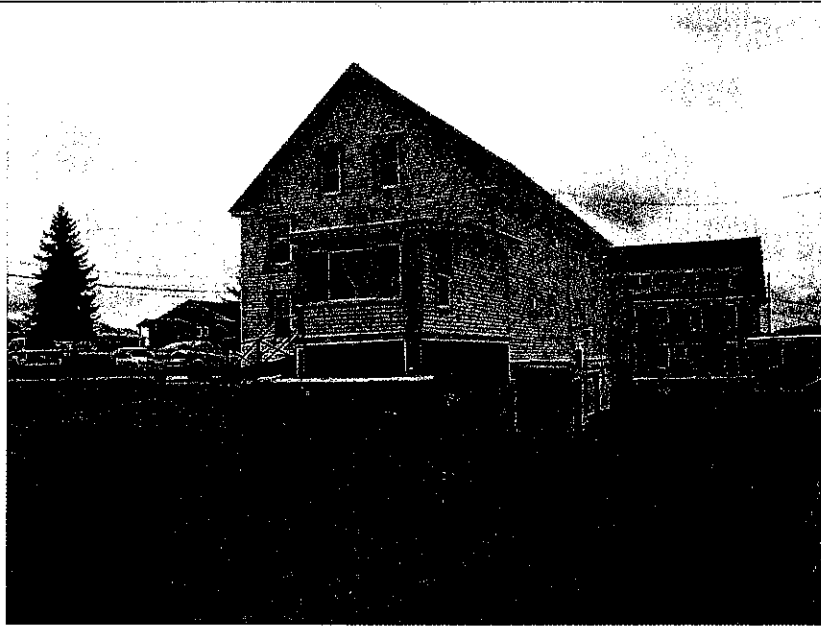
**Photograph 52** - 04/27/05 – Apartment Building (Building #19): West elevation with sun porch and basement entry.

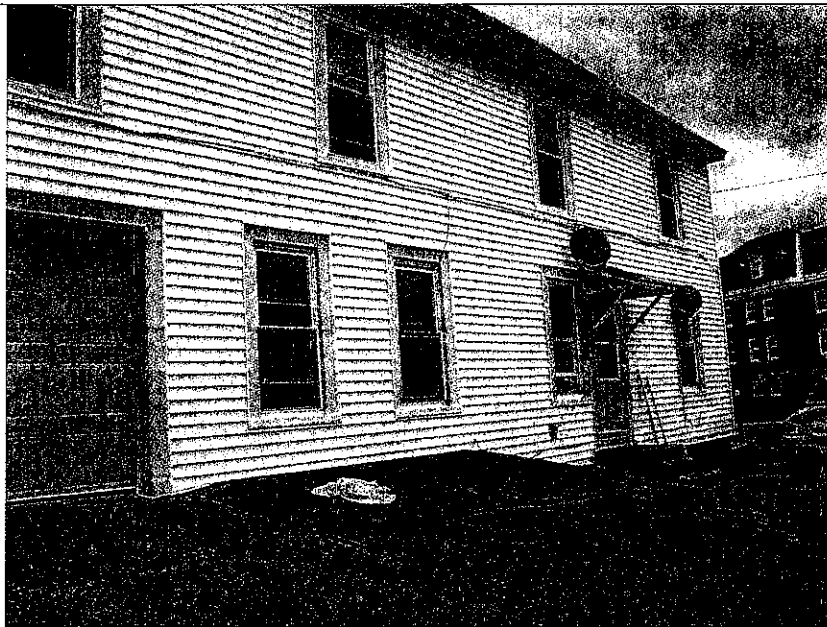
**Photograph 54** – 04/27/05 – Apartment Building (Building #19): south elevation

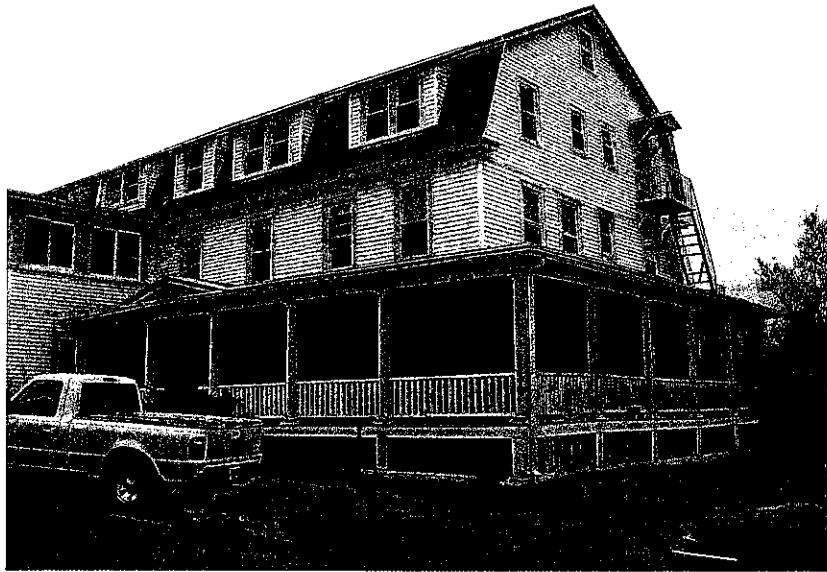
**Photograph 58** - 04/27/05 - Maple Hill (Building #20): North Elevation with covered porch.

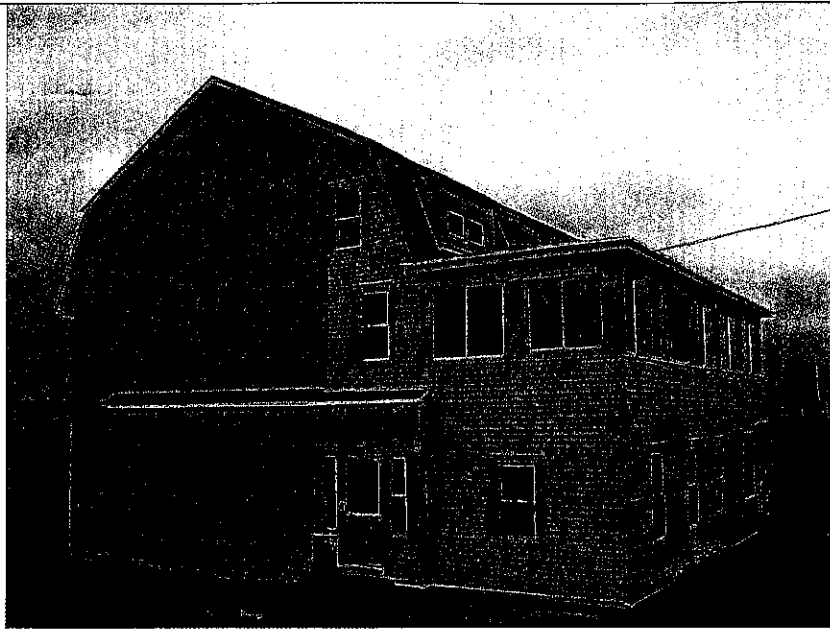
**Photograph 59** - 04/27/05 – Maple Hill (Building #20): South elevation with patched area from the fire.

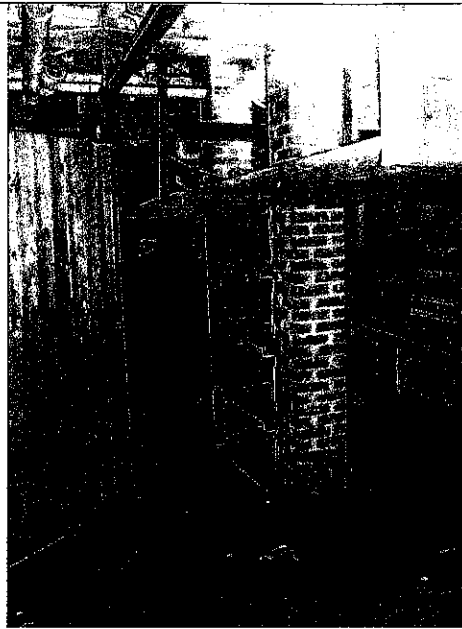
**Photograph 61** – 04/27/05 – Maple Hill (Building #20): Basement with standing water.

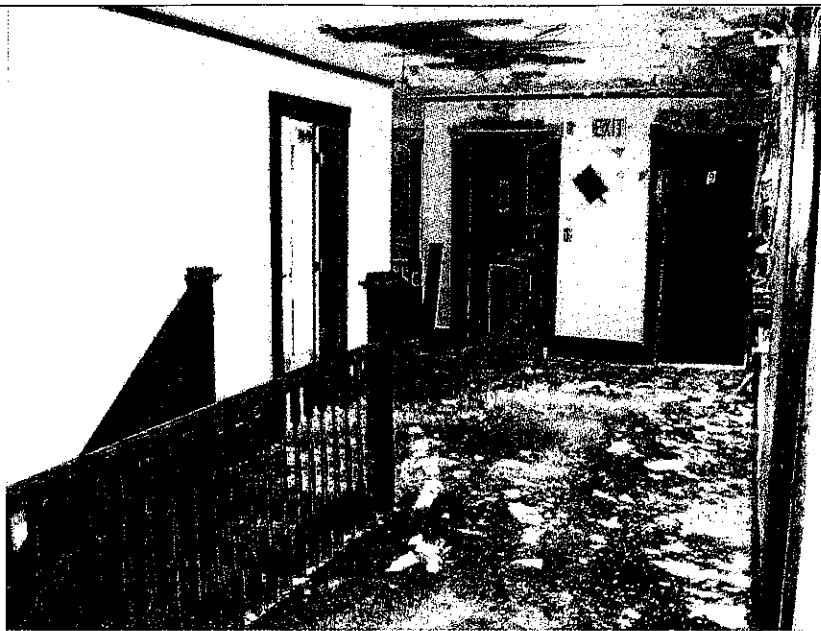
**Photograph 63** – 04/27/05 – Maple Hill (Building #20): Central stair on second floor..

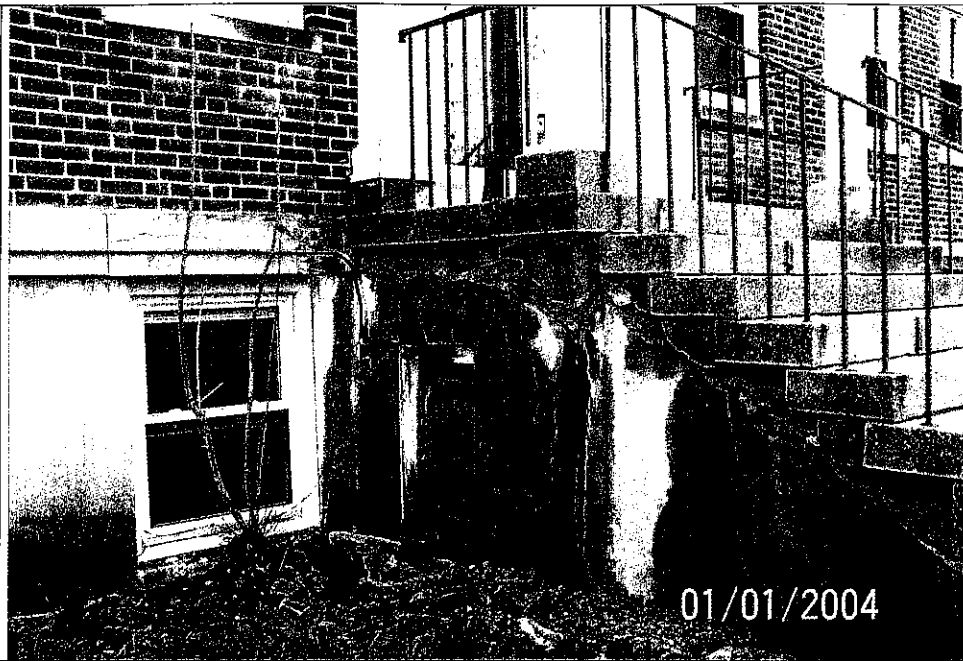
**Photograph 1** – 04/28/05 – Sanders Building (Building #3): Front concrete exterior stair

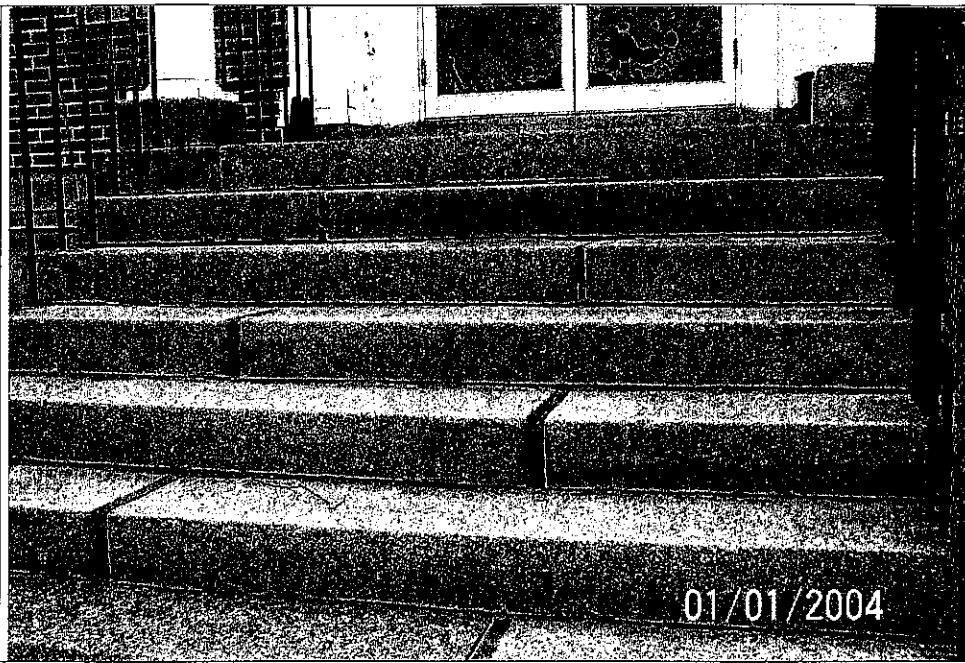
**Photograph 3** – 04/28/05 – Sanders Building (Building #3): Exterior steps

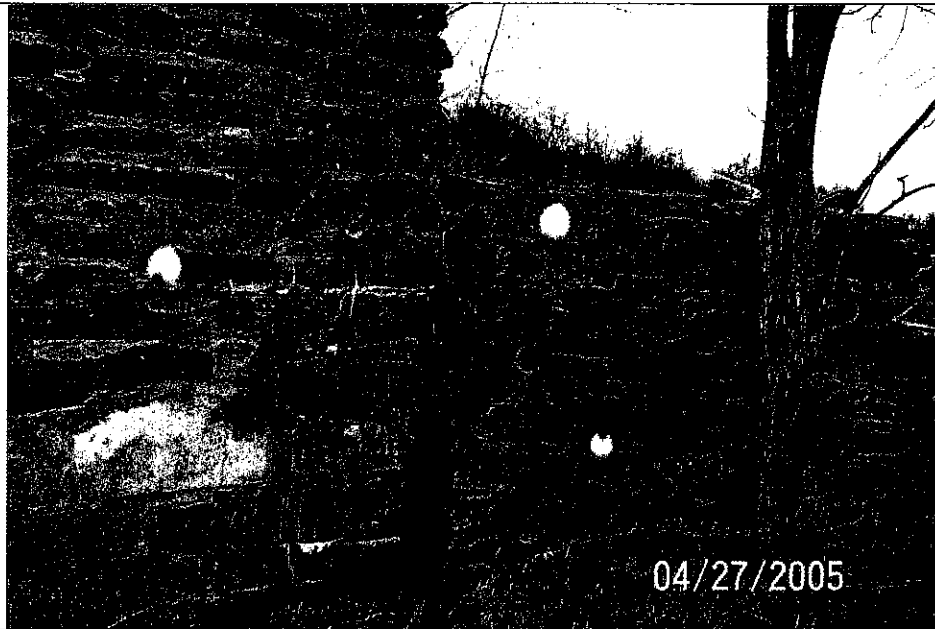
**Photograph 13** - 04/28/05 – Root Cellar (Building #4): Retaining wall #2 is unstable

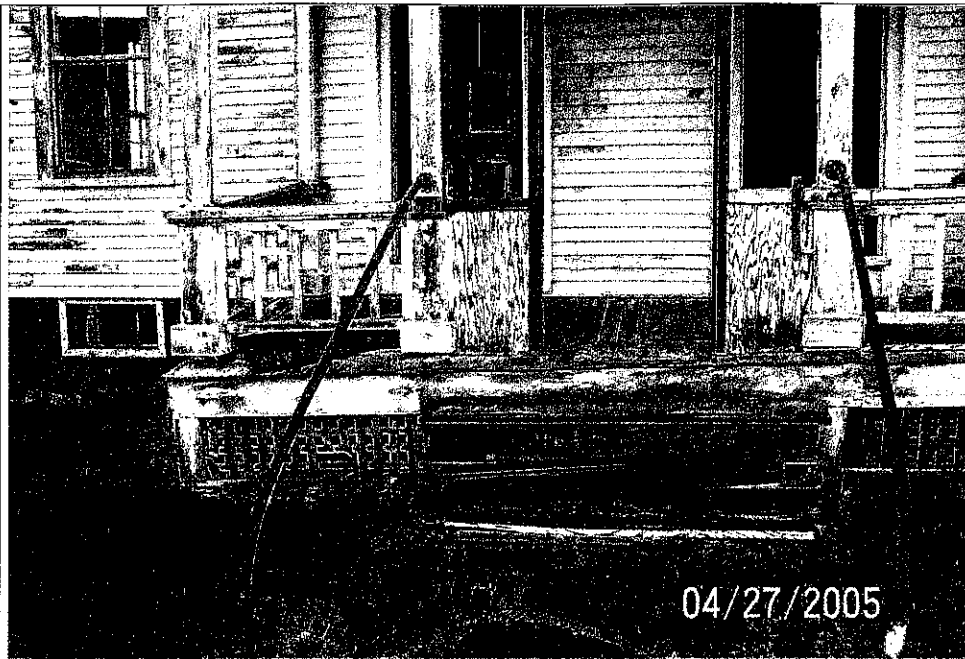
**Photograph 31** – 04/27/05 – Men's Annex (Building #15): Front porch

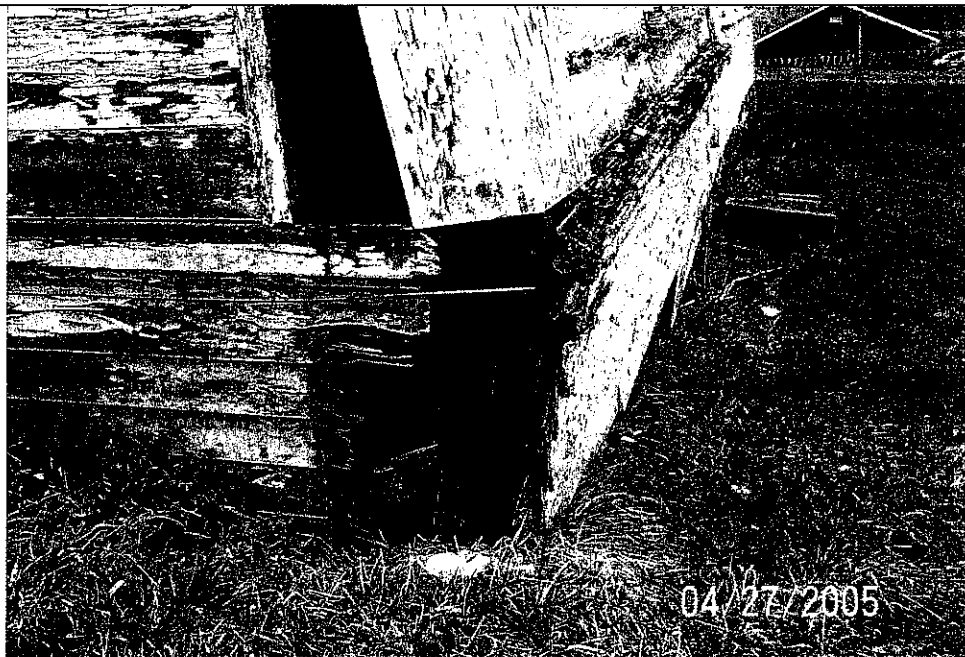
**Photograph 32** – 04/27/05 – Men's Annex (Building #15): Rear addition's exterior wall

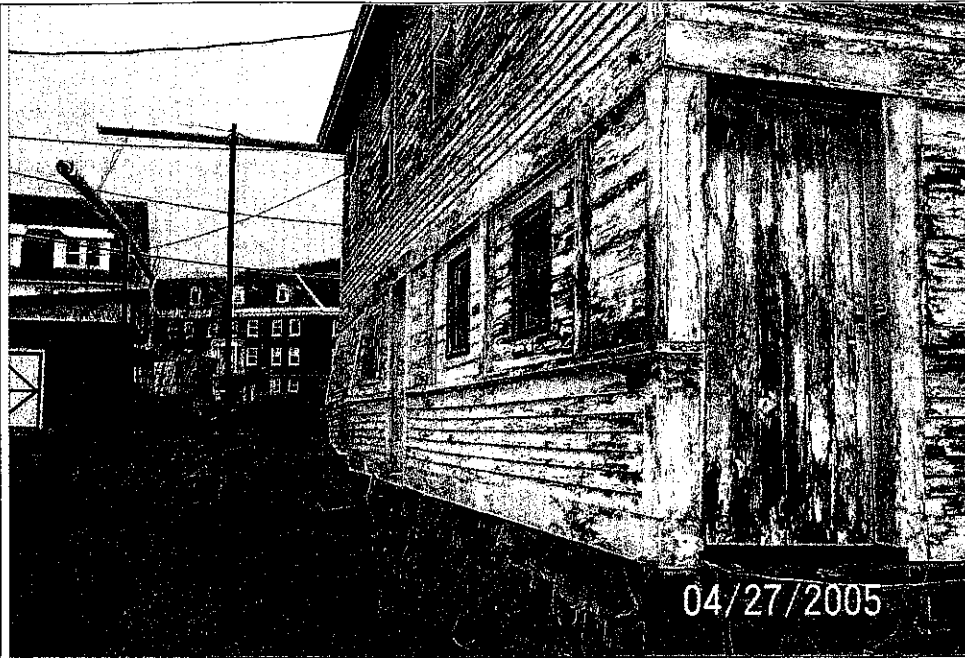
**Photograph 33** – 04/27/05 – Men's Annex (Building #15): Rear addition

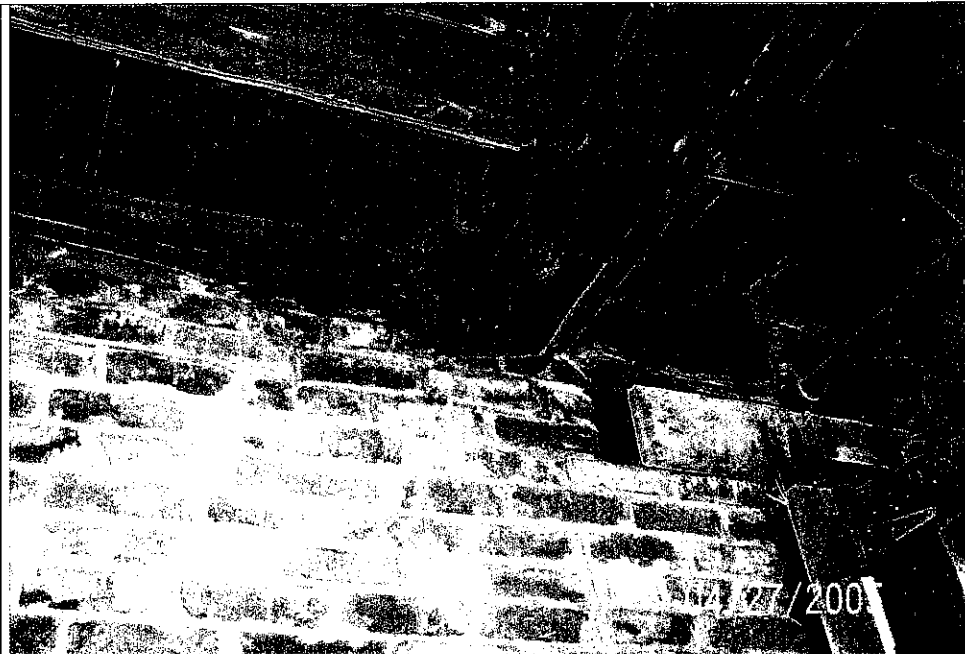
**Photograph 34** – 04/27/05 – Men's Annex (Building #15): Wood girder at first floor

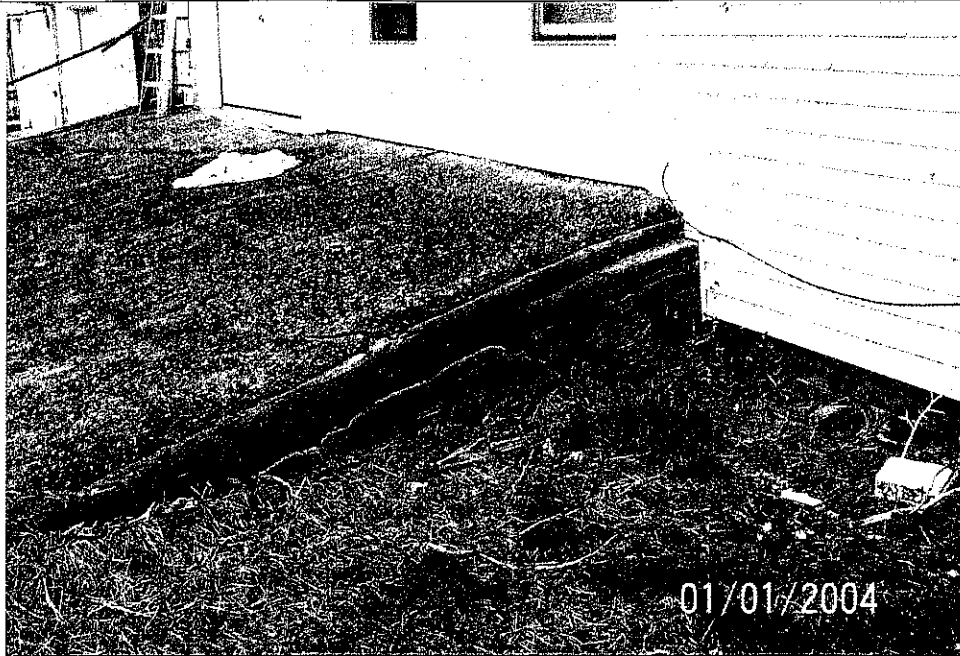
**Photograph 43** – 04/27/05 – Apartment Building (Building #19): exterior concrete driveway;  
exterior vinyl siding

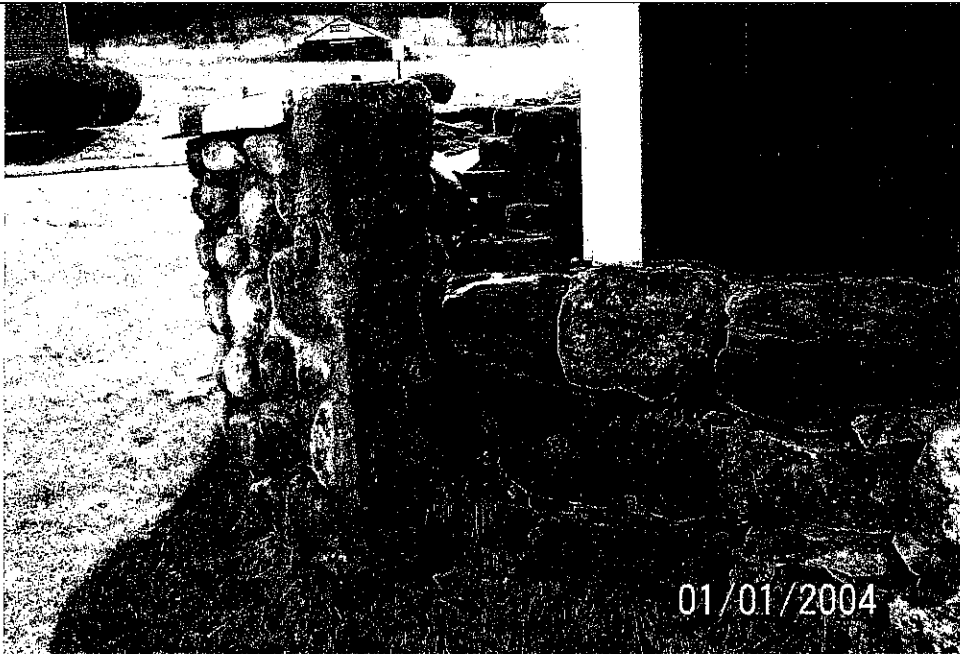
**Photograph 44** - 04/27/05 – Apartment Building (Building #19): Exterior stone retaining wall

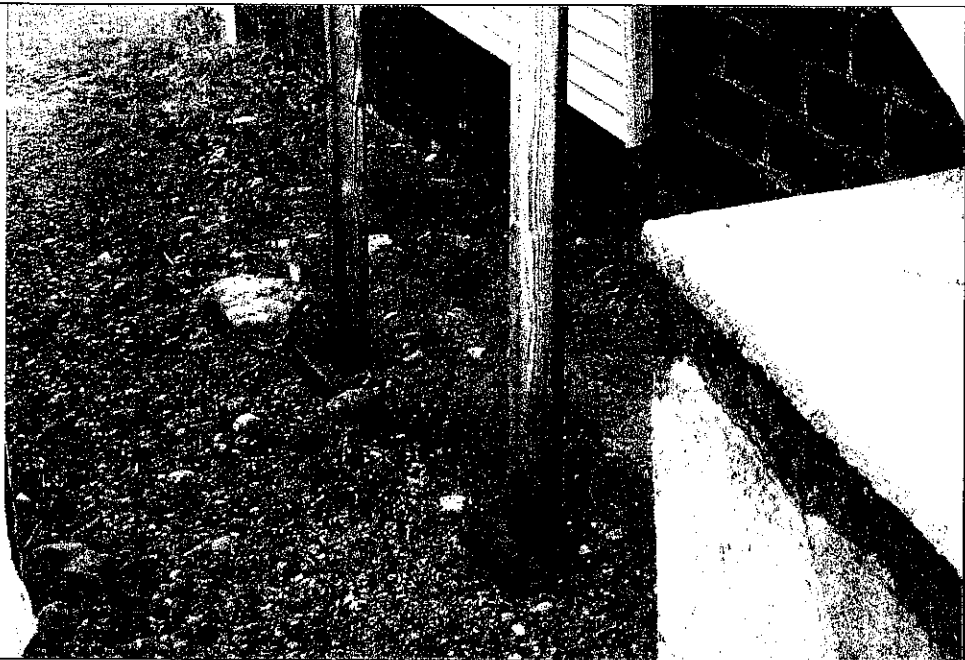
- The two wood posts supporting the lower portion of the stairs do not have an adequate foundation, and the posts have settled. Concrete piers should be poured for the stair post supports. Cross-bracing and additional reinforcement for the posts should also be installed. *See photo 52.*

**Photograph 52** - 04/27/05 – Apartment Building (Building #19): Exterior porch stair post supports
